American Honda Motor Co., Inc.

SAFETY AND EMISSIONS **RECALL NOTICE**

EU2000i Portable Generators

FUEL TUBE LEAK

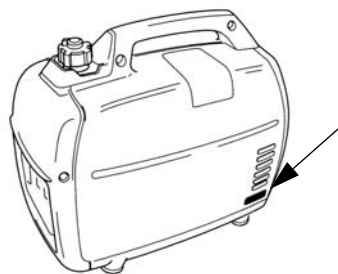
Serial Number
Location

Affected Model	Start Serial Number	End Serial Number
EU2000i	EAAJ-2260273	EAAJ-2485025

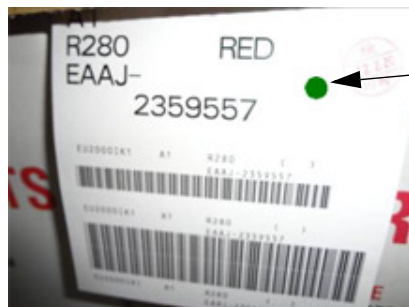
Boxed generators are identified by a "green dot" located on the carton.

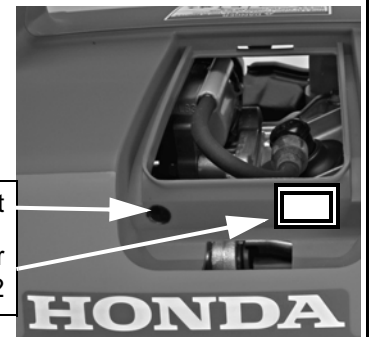
Also, one of the markings shown to the right, located inside the spark plug access cover.

Black dot
or Honda sticker
7D1 or 7D2
