PRODUCT UPDATE NOTICE

BF200D • BF225D • BF250D Outboards

COOLING SYSTEM INDICATOR

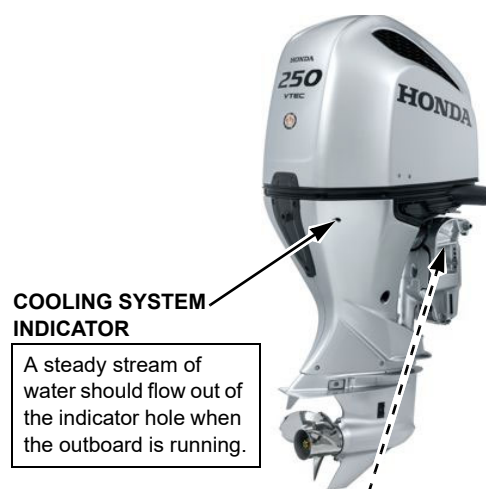
COOLING SYSTEM INDICATOR

A steady stream of water should flow out of the indicator hole when the outboard is running.

SERIAL NUMBER

The serial number can be found on the left-hand side of the transom mounting bracket.

Please contact your Honda Marine servicing dealer to make arrangements to have your BF200D, BF225D, or BF250D repaired. The dealer will install a metal retaining clip onto a rubber hose in the cooling system indicator, and if required, perform a multi-point inspection at no charge to you. Transportation of the outboard to the dealer is the responsibility of the owner.
