American Honda Motor Co., Inc.

SAFETY AND EMISSIONS **RECALL NOTICE**

BF2.3DK2 PORTABLE OUTBOARD MOTOR GAS CAP VENT LEAK

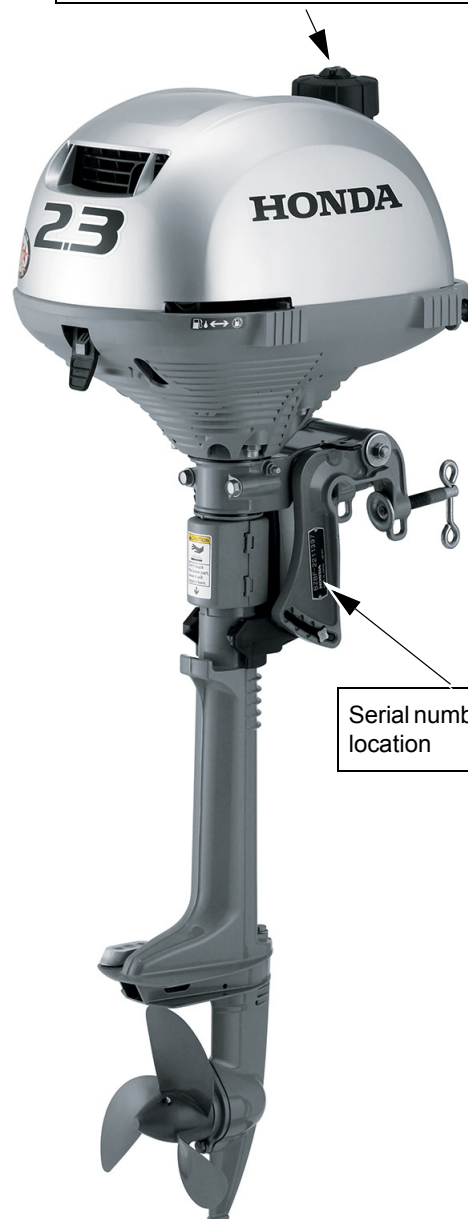
Serial number location

Units within the affected serial number range have a defect that can result in the gas cap vent gasket becoming misaligned. If the gas cap vent gasket becomes misaligned, gas can leak from the cap when its vent knob is in the OFF position and the outboard motor is placed on its side (horizontally).

Gas may leak from the gas cap vent.

- If your outboard motor was registered with American Honda, you will receive a letter with a new updated gas cap.
- If your outboard motor was not registered with American Honda, contact your Honda Marine servicing dealer for a free replacement gas cap.
- If you transport or store your outboard motor horizontally and have yet to install an updated gas cap, drain all the gas from the gas tank before placing the outboard motor on its side.
