# **SAFETY RECALL NOTICE**

## FG110K1AT Mini-Tiller **THROTTLE CABLE / ENGINE STOP SWITCH WIRE PINCHED**

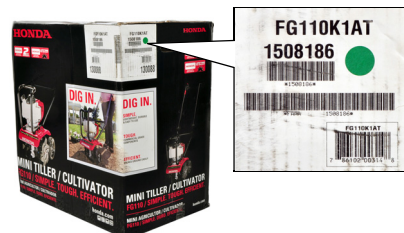
FRAME SERIAL  
NUMBER

Affected Model	Starting Serial Number	Ending Serial Number
FG110K1AT	FAAA-1200001	FAAA-1540521

Units previously inspected/repaired, identified by a “green dot” located on the carton, are no longer affected by this recall.

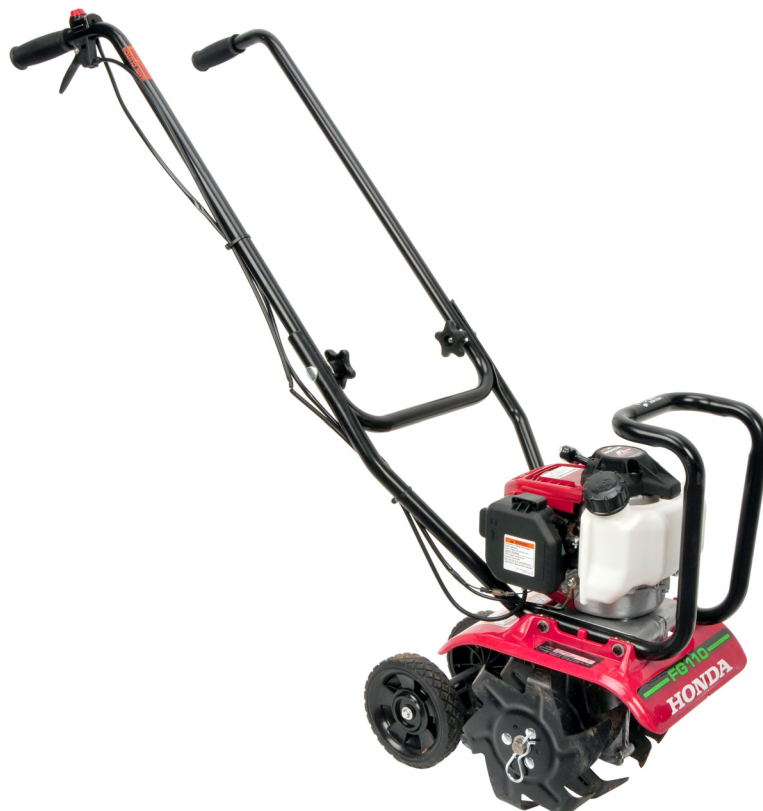
Due to a packaging error at the factory, the throttle cable or engine stop switch wire may have been pinched between the upper and lower handle pipes when the handle was folded for packaging.

If the throttle cable or stop switch wire is pinched as a result of the factory packaging error, the tiller tines may immediately begin to spin upon start-up or the engine may not be able to be turned off.

Before using your mini-tiller, follow the *Before First Use Inspection* shown on page 2 to identify if there is damage to the throttle cable or engine stop switch wire. If your new mini-tiller shows no signs of damage and the throttle lever operates correctly (tines don't turn immediately during start-up), please disregard this notice. If you find a damaged throttle cable or engine stop switch wire, or you do not feel comfortable inspecting your unit, please contact your local authorized Honda servicing dealer for inspection or repair. For more information on this recall or to find a dealer near you, contact Honda Power Equipment Customer Relations at:

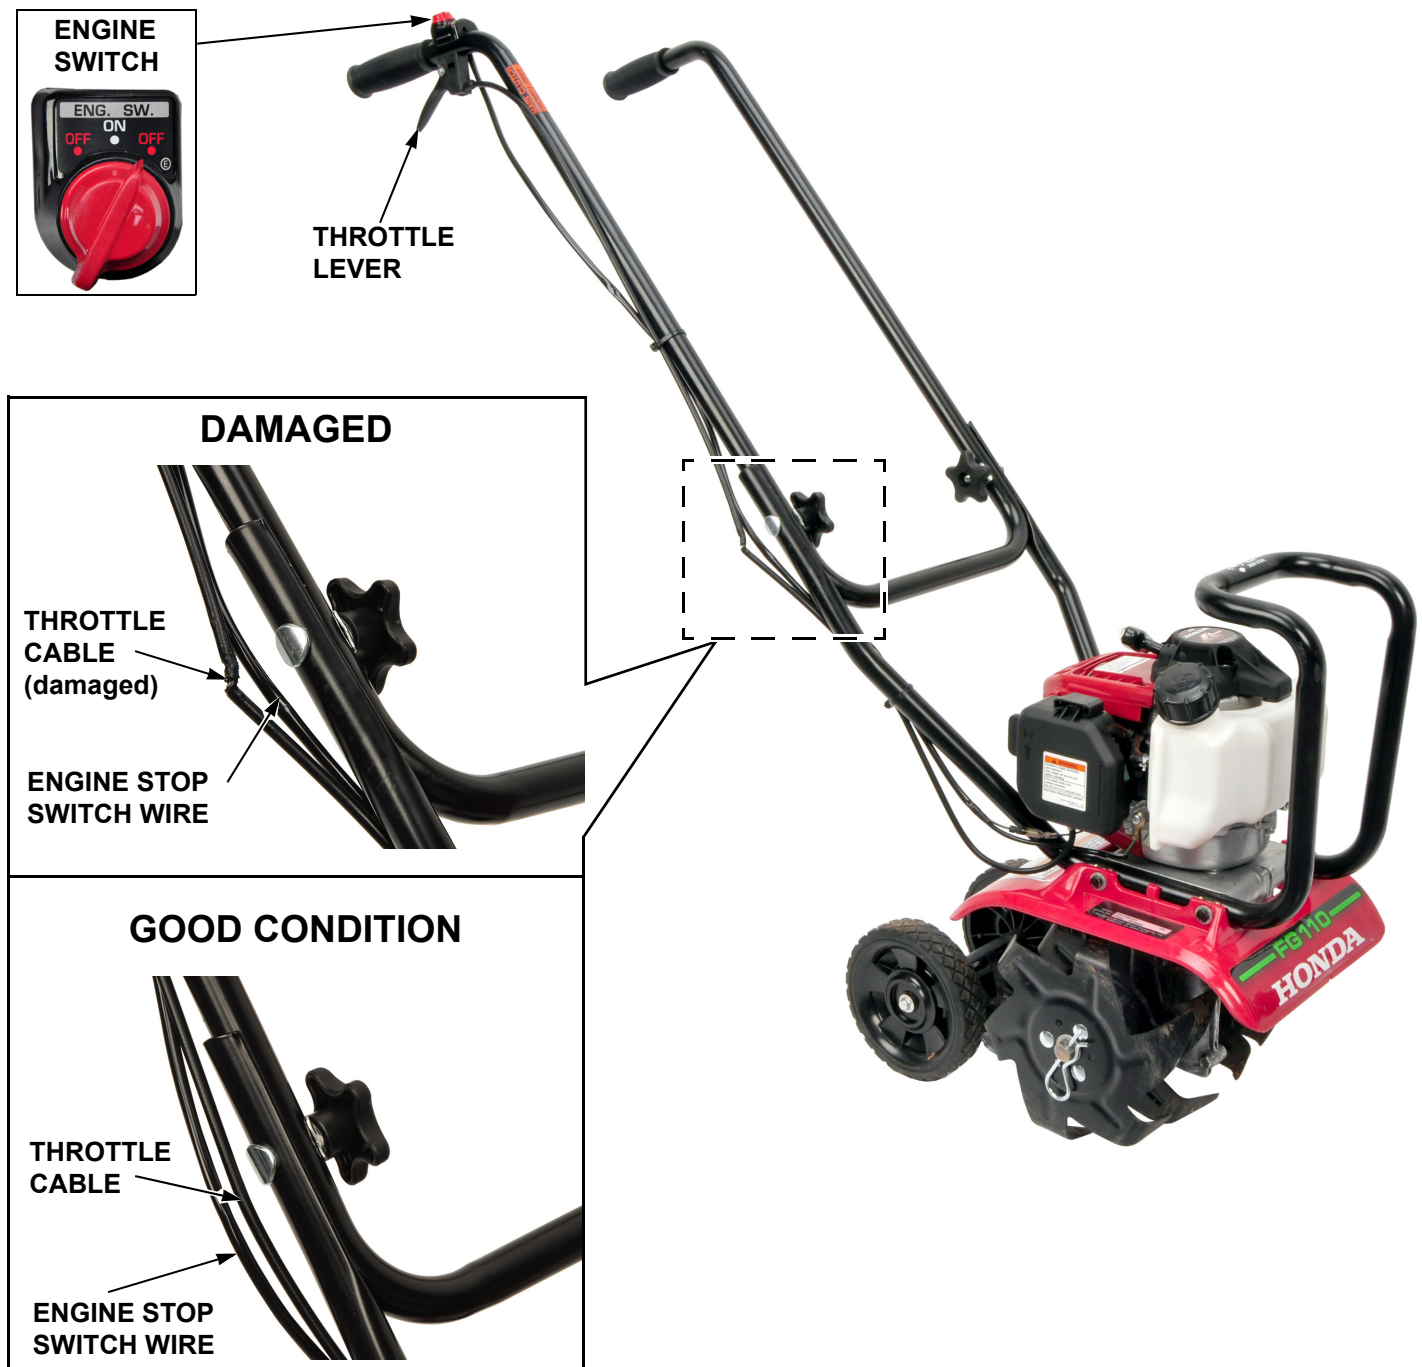
## BEFORE FIRST USE INSPECTION

Inspect your mini-tiller in the area shown below to determine if the throttle cable or engine stop switch wire is kinked, pinched, or damaged. Do **not** start the mini-tiller if you notice damage to the throttle cable as the tines may not be able to stop.

1. Locate the throttle cable and engine stop switch wire that is attached to right-hand side of the handlebar.
2. Inspect the throttle cable and engine stop switch wire and look for any damage. The cable and wire should be straight and smooth without any kinks, hard bends, or visible damage. The throttle lever should move freely without any binding. The engine should start and run when the engine switch is in the ON position, and should stop when the engine switch is in the OFF positions.

**Before using your mini-tiller, inspect the throttle cable and engine stop switch wire for damage caused during factory packaging. If damage is found, do not attempt to use your mini-tiller before repair. Contact your local Honda Power Equipment servicing dealer to have it repaired free of charge.**

If you find any damage to the throttle cable or engine stop switch wire, contact your local dealer for assistance.
